NIST NCSTAR 1-5A

**Federal Building and Fire Safety Investigation of
the World Trade Center Disaster**

Visual Evidence, Damage Estimates, And Timeline Analysis

William M. Pitts
Kathryn M. Butler
Valentine Junker

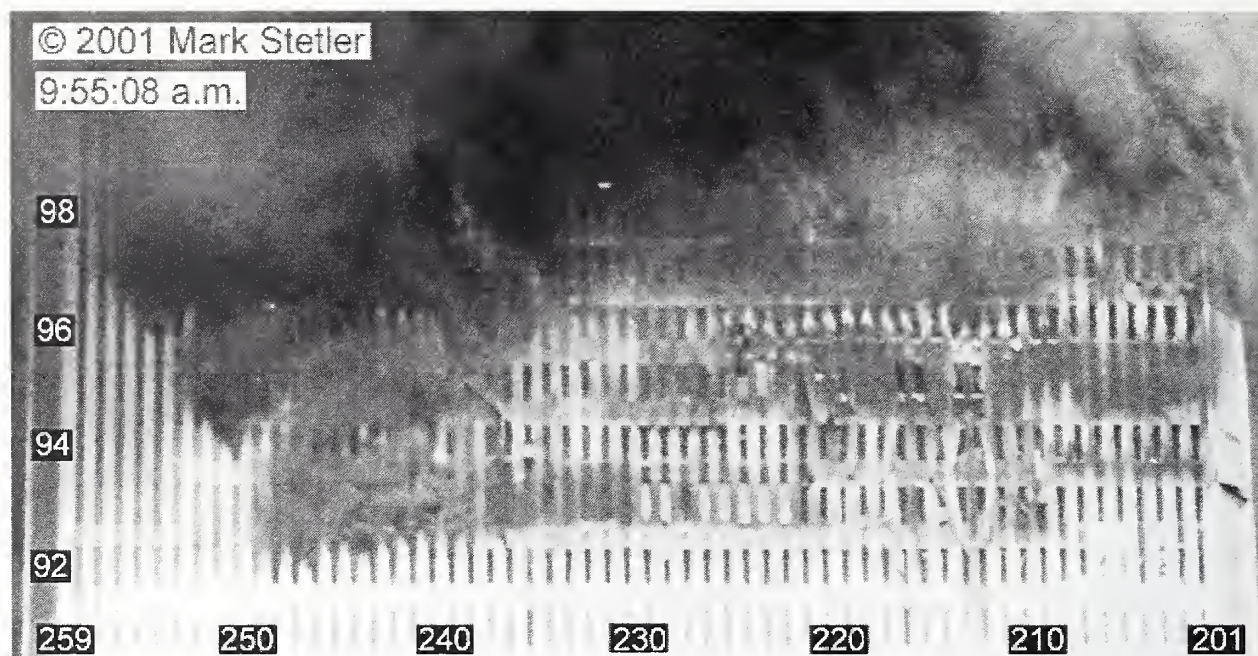
Figure 8-59 includes a photograph of the east face that was taken roughly eight and one half minutes (at 9:55:08 a.m.) after that shown in Figure 8-59. The fire burning on the 98th floor has continued to spread. It now extends from window 98-225 on the south to window 98-201 on the north. There is flame extension from windows 98-208 to 98-223. The fire has clearly moved into the room on the northeast corner, but the fire inside the room is burning at a lower intensity than the main fire region to the south.

Figure 8-59. This photograph shows the east face of WTC 1 at 9:55:08 a.m. The original has been rotated, cropped, and enhanced. Column and floor number have been added.

The fire on the 92nd floor has not moved further south than window 92-248 during the interval, but it has grown larger in the immediate area. The windows from window 92-240 to window 92-248 appear to be filled with flames, and there is some flame extension in the area. The fire on the 94th floor also seems to have remained in place, but it has decreased in intensity. The appearance of the fire on the 95th floor is little changed from the earlier photograph.

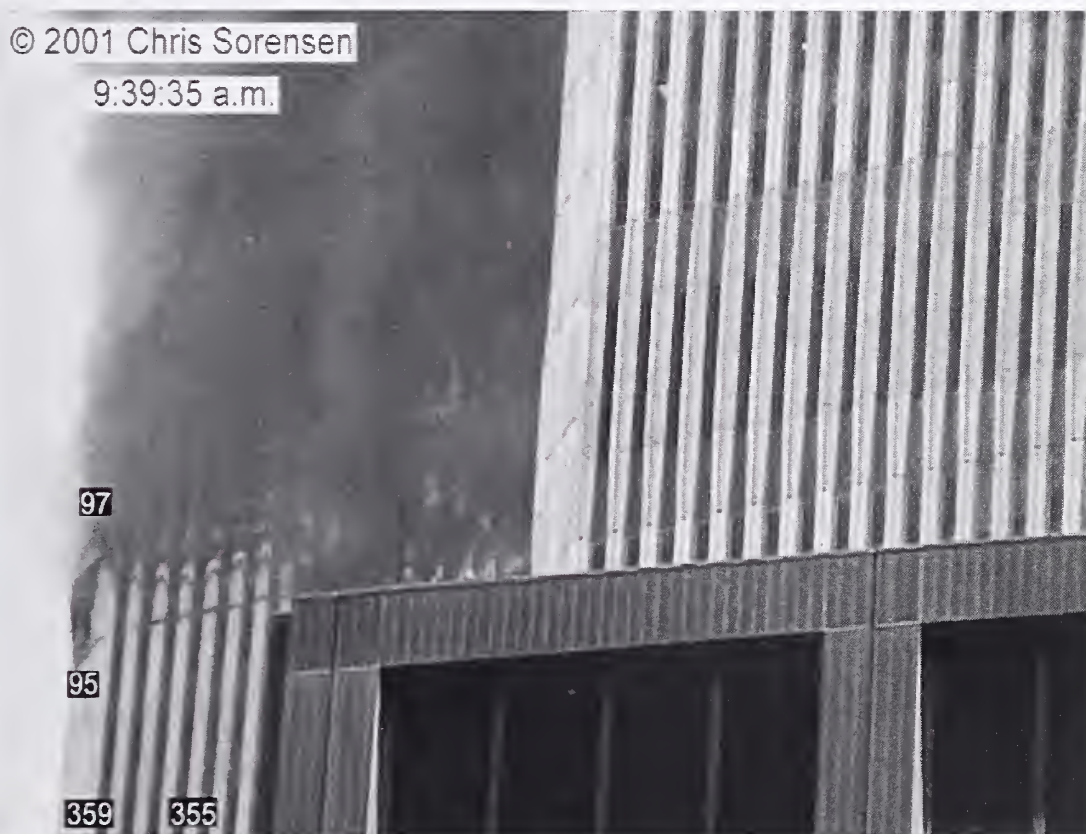
Figure 8–60 shows a partial view of the south face of WTC 1 taken from a video recorded at 9:39:35 a.m. WTC 1 is behind WTC 2, which appears to the right in the image. The first column that is visible on WTC 1 is column 343. The top of the 95th and higher floors are visible. Flames are visible on the 95th, 96th, and 97th floors, but the fire intensity appears to have decreased from that observed in Figure 8–46, which was taken at 9:33:13 a.m. Note that it is possible to see parts of the 98th floor through the smoke, and no flames are apparent.

Figure 8-60. This image of the south face of WTC 1 was captured from a video recorded at 9:39:35 a.m. It has been enhanced by adjusting the intensity levels. WTC 1 is on the left behind WTC 2. Another building appears in the foreground. Column and floor numbers have been added.

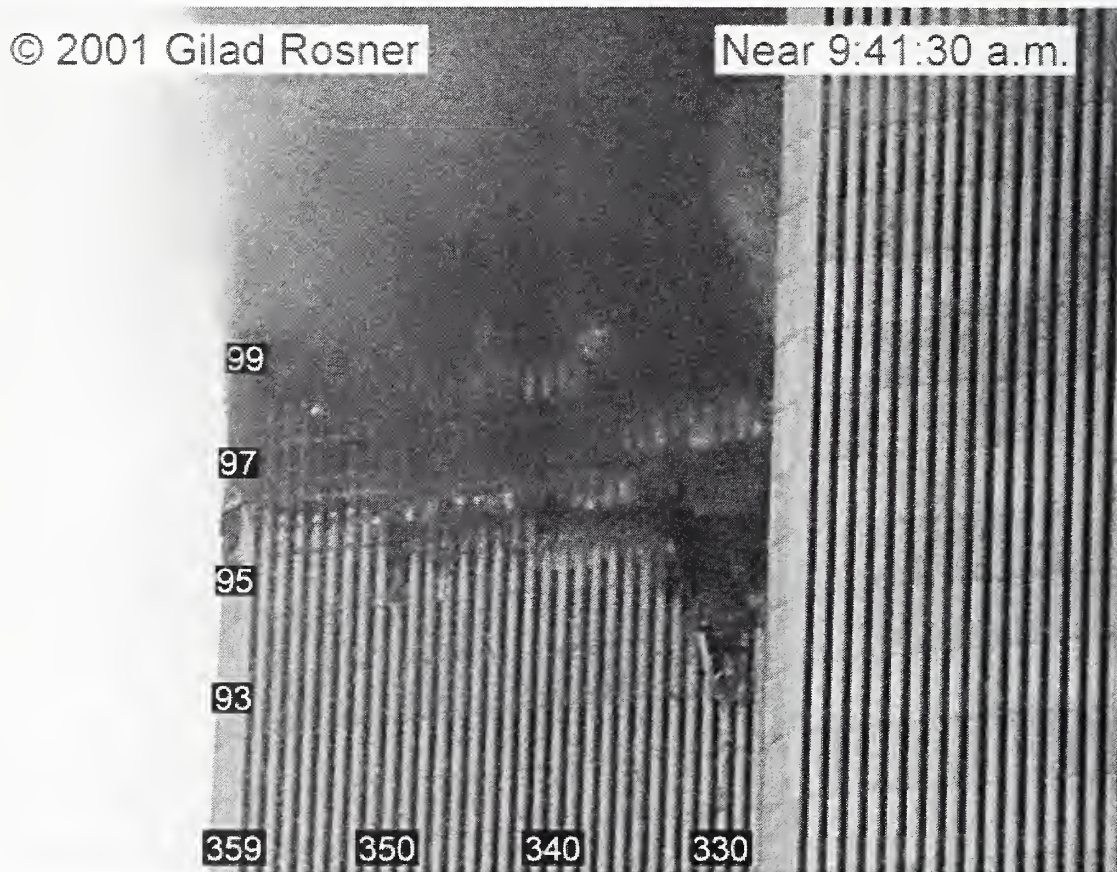
The photograph in Figure 8–61 was taken shortly after the initial rapid fire growth on the south face took place on the 98th floor. The exact time of the photograph is unknown. The assigned time of 9:41:30 a.m. has an uncertainty of just over one minute. The fire on the 98th floor has already covered a number of windows, and flames are extended from many of these. Significant fires are also evident on the 95th, 96th, and 97th floors. The intensities of these fires have continued to decrease relative to earlier times. Burning is also present on the 94th floor near the center of the face, where the panel section is believed to have been displaced during the aircraft impact. Flames were not evident at this location in Figure 8–46, which was taken at 9:33:13 a.m.

Figure 8-61. This untimed photograph shows the south face of WTC 1. It is estimated that it was taken between 9:40:40 a.m. and 9:42 a.m. Column and floor numbers have been added.

Another photograph (not shown) taken around this same time (estimated to be 9:42:25 a.m.) shows a fire distribution on the west side of the south face similar to that seen in Figure 8–61. However, unlike Figure 8–61, this image also shows the east side of the face. Small flames are visible on the 94th floor in windows 94-328 and 94-327 to the immediate east of the area where the panel section is believed to have been dislodged. Flames are also visible higher up on the 95th floor (windows 95-328 to 95-324) and the 97th floor (windows 97-330 to 97-325). Further to the east a small spot fire is visible inside window 94-308 on the 94th floor and light smoke is coming from the window. This window remains the only open window on this section of the façade, and it has been open since the aircraft impact. This small fire is the first indication that fire has spread into locations near the southeast corner of the tower on any floor.

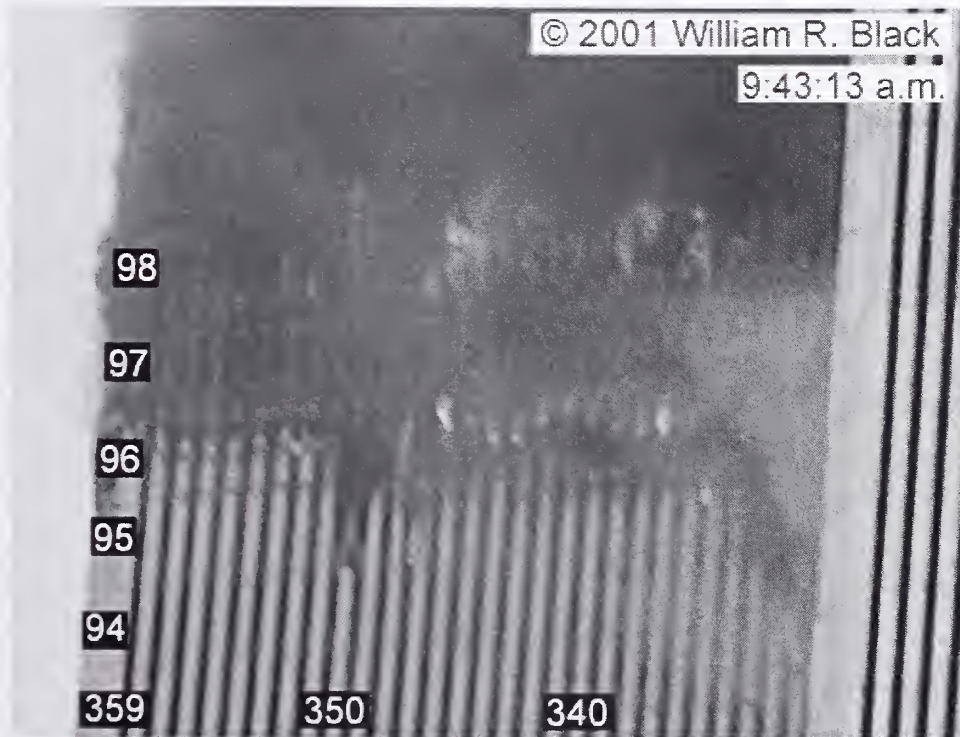
Figure 8–62 shows a partial view of the south face recorded at 9:43:13 a.m. The intensity of the fire on the 98th floor has increased markedly from that seen in Figure 8–61. Fire is now evident from at least window 98-335 to window 98-356. Well over ten of the windows on this floor have large extended flames. Forty seconds later the fire on the 98th floor had grown still more intense as shown in the somewhat closer view of the area reproduced in Figure 8–63. Flames are evident as far west as window 98-357. It is clear from this photograph that, while the intensities of the fires on the 95th, 96th, and 97th floors have decreased from earlier times, vigorous burning is still taking place on each of these floors. A small fire is burning on the 94th floor in window 94-332.

Figure 8-62. This cropped photograph of the south face of WTC 1 was recorded at 9:43:13 a.m. The image has been rotated and enhanced. WTC 2 appears at the right. Column and floor numbers have been added.

Comparison of Figure 8–60 to Figure 8–62 verifies the observation from the video that an intense fire appeared on the south face of the 98th floor shortly after 9:40 a.m. and very rapidly covered most of the western half of the face.

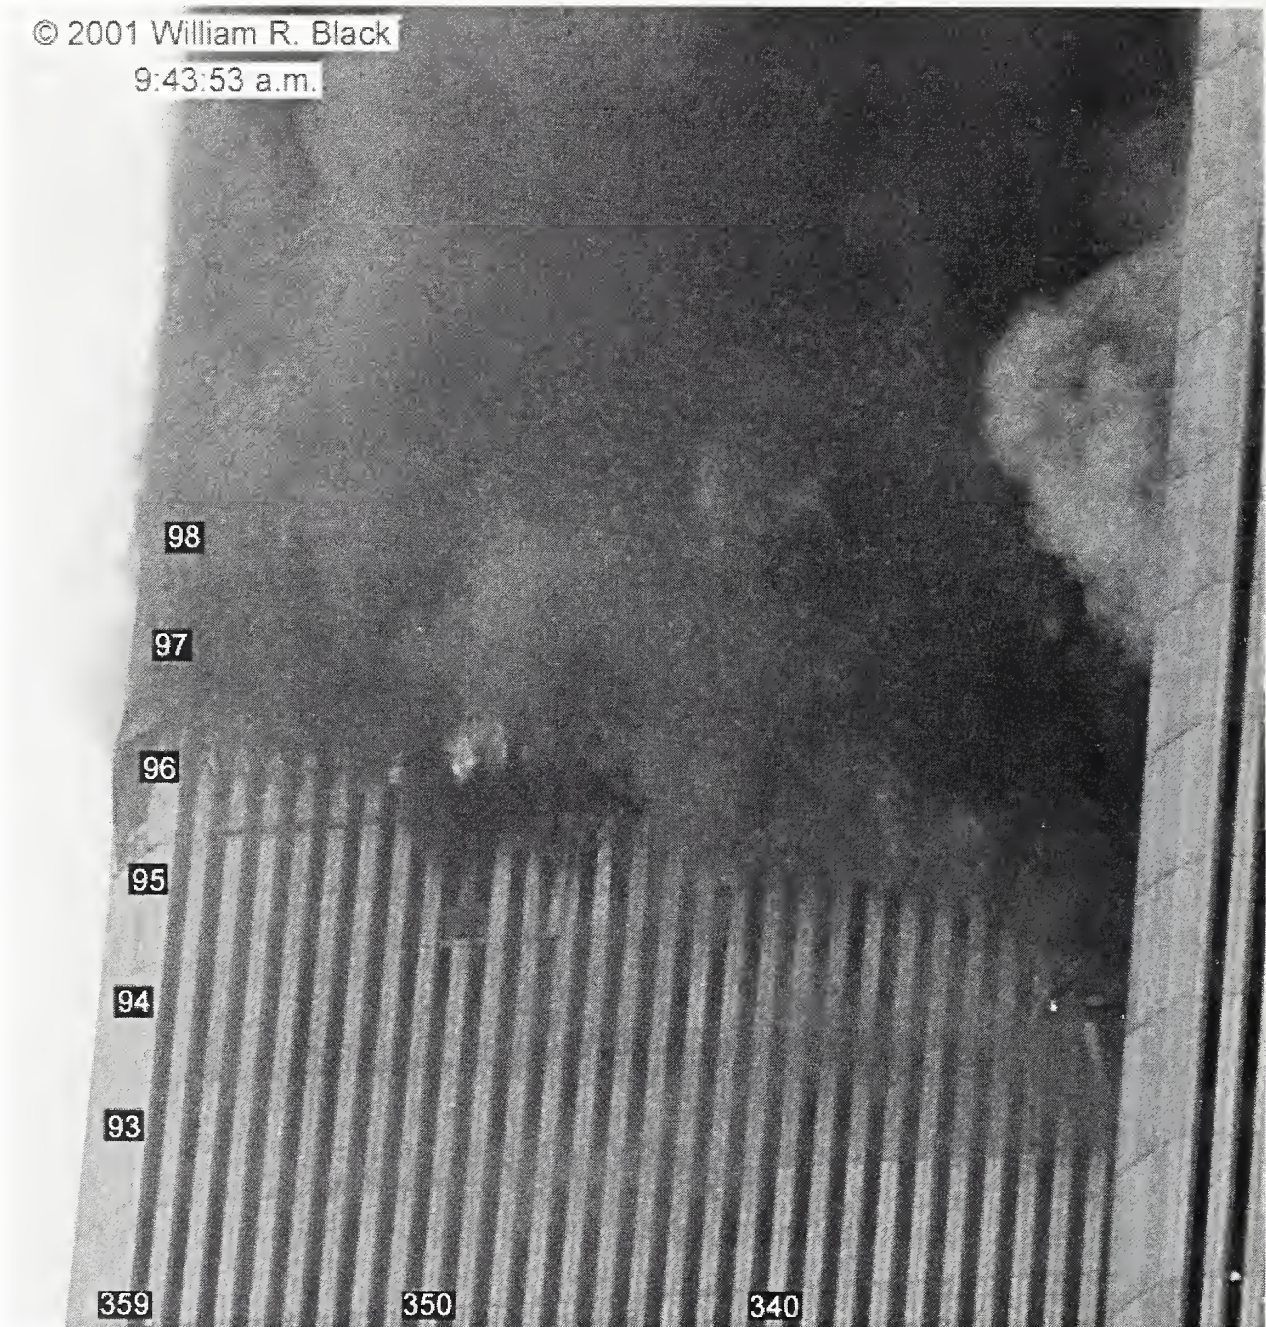
Figure 8-63. This cropped photograph of the south face of WTC 1 was recorded at 9:43:53 a.m. The image has been rotated and enhanced. WTC 2 appears at the right. Column and floor numbers have been added.

Even though it has been over an hour since the aircraft struck WTC 1, the majority of flames observed on the south face are still present to the left, i.e., west, of column 330. However, unlike earlier times, there are indications that fires have begun to burn in the southeast quadrant of the tower. There appears to be a small fire visible near window 94-315 in Figure 8-64. In another photograph, taken at roughly the same time, flames with a similar intensity are visible at window 94-314. Figure 8-65 provides a view of the south face at 9:53:47 a.m. taken from the southwest. While flames are not apparent in this area of the 94th floor from this angle, smoke is visible coming from at least two locations on the 94th floor to the

east of the center. Window glass appears to be missing in other nearby windows. Taken together, these observations suggest that a relatively low intensity fire is present at this time on the 94th floor on the east side of the south face.

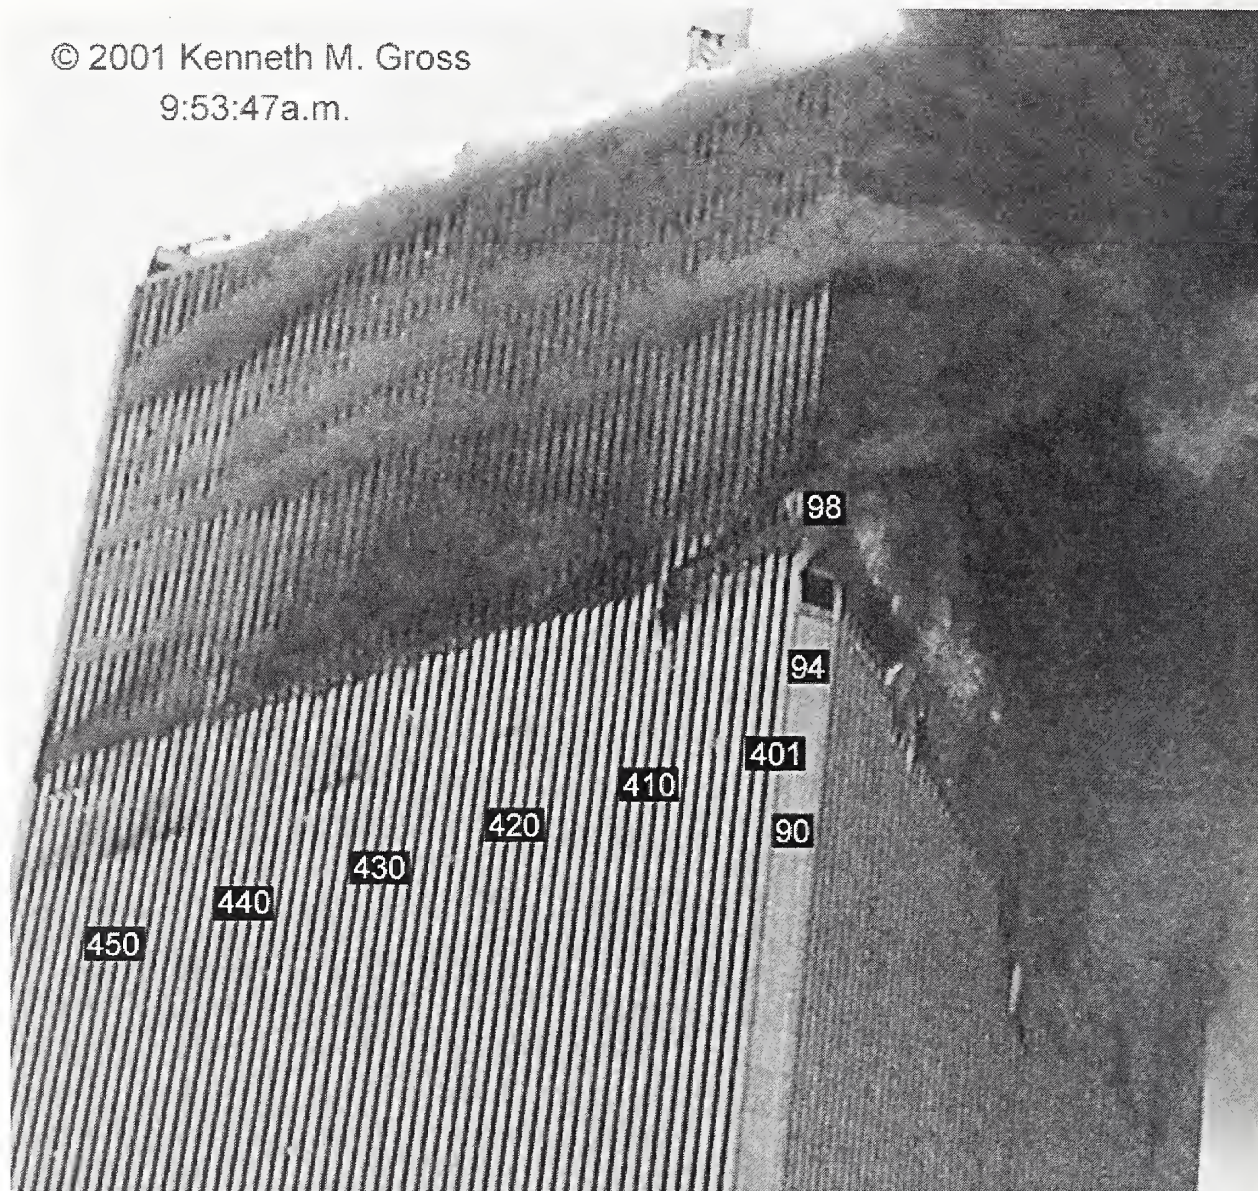
9:53:47a.m.

In Figure 8–65 there are indications of smoke coming from windows on the 93rd floor just to the right of the area where the panel section is believed to be missing. Higher floors on the east side are partially obscured by smoke, but there are no indications of intense fires or heavy smoke on this side for levels above the 94th floor. This figure provides a good qualitative indication of the relative intensity of the recently developed fire on the 98th floor as compared to the fires that had been burning longer on the 95th to 97th floors.

is clear that intense flames are present over several floors in the area at the center of the face where the panel section is likely missing.

Figure 8-65. A photograph shot from the southwest shows the west and south faces of WTC 1 at 9:53:47 a.m. The original image has been cropped and enhanced. Column numbers for the west face and floor numbers have been added.

Fires are visible on the west face of the 94th floor in Figure 8-65. The smoke marks at the tops of the covers for columns 94-121 and 94-122 are distinct, indicating that the fire has opened windows in the room with walls at columns 94-421 and 94-425 (see Figure B-3). The dark red glow of the fire on the 98th floor that extends north from the south edge of the west face is also visible in Figure 8-65. This particular photograph provides a graphic illustration of the differences in burning behavior observed on the west and south faces for fires on this floor. Compare the intense flames extending from multiple windows of the 98th floor on the south face with the red glow present on the west face.

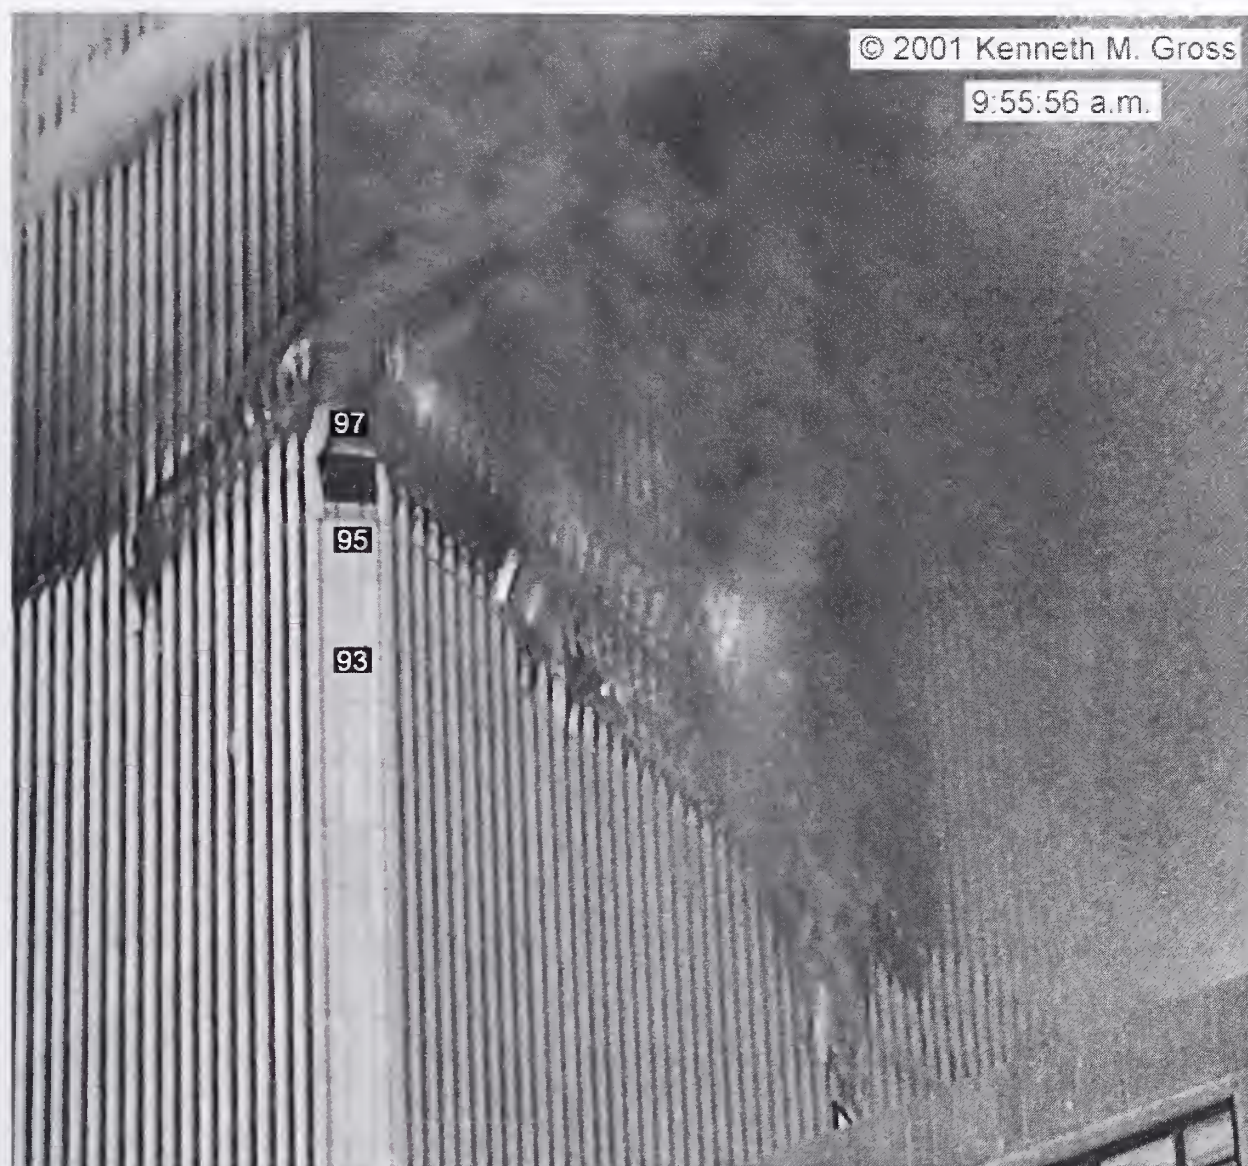
Figure 8-66. A photograph shot from the southwest shows the west and south faces of WTC 1 at 9:55:56 a.m. The original image has been cropped and enhanced. Floor numbers have been added.

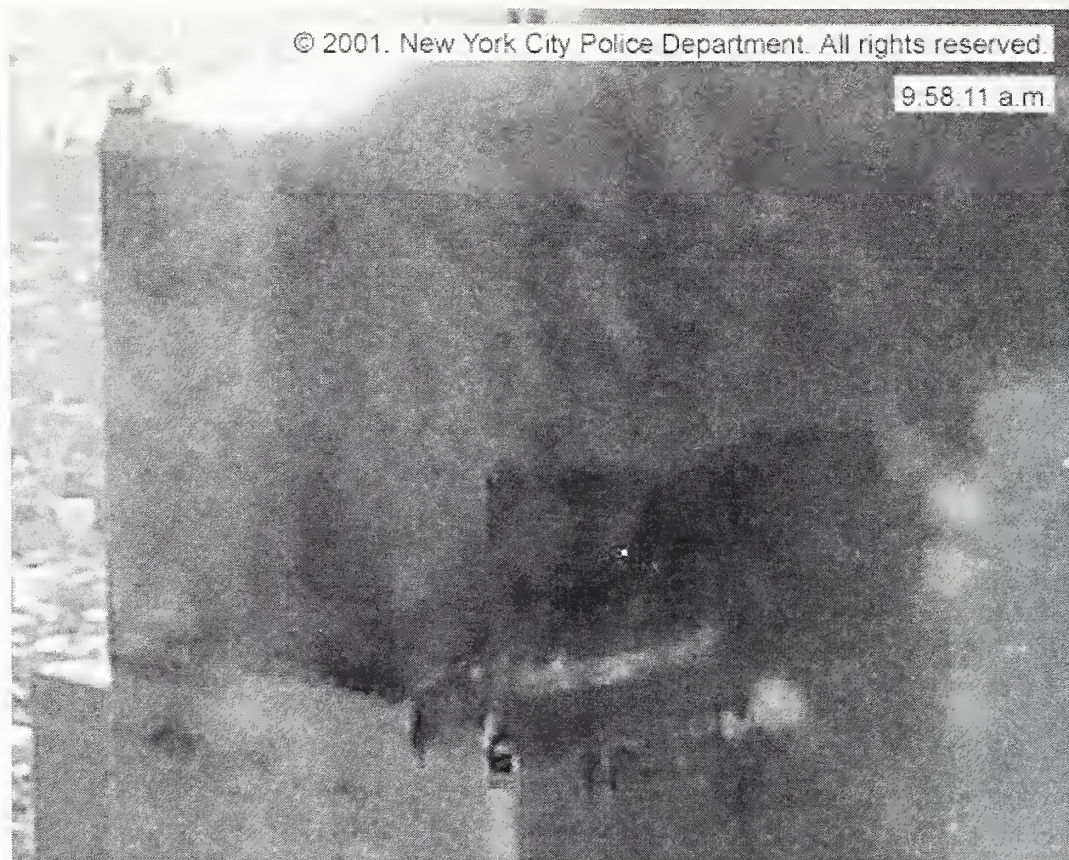
An image of WTC 1, taken roughly a minute prior to the collapse of WTC 2, is shown in Figure 8-67. This photograph was shot from a helicopter looking down on the southwest corner of the tower. The fire on the 98th floor of the south face continues to burn intensely at this time, with limited flame extension from windows. Fires present on the 95th to 97th floors have continued to decrease in size, with one exception. On the 96th floor long flames extend from the area near the center of the south face where the panel section is believed to be missing. From this angle there is no indication of flames on the eastern side of the face.

Figure 8-67. This cropped photograph showing the southwest corner of WTC 1 was shot from a helicopter around 9:58:11 a.m. The time has an uncertainty of 30 s. The original image has been cropped and enhanced.

The photograph shot from a helicopter shown in Figure 8-67 was taken less than a minute before the collapse of WTC 2. The appearance of the west face of WTC 1 at this oblique angle is consistent with the fire distributions described above.

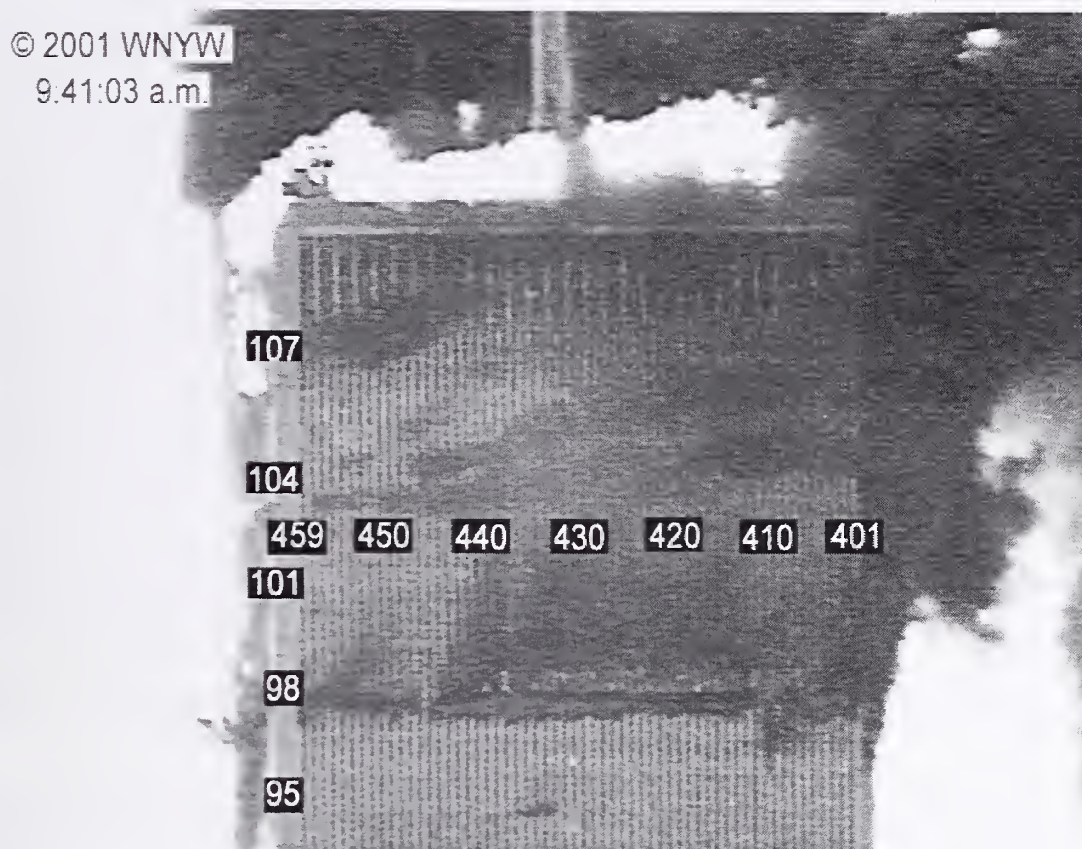
The relative amounts of fire visible on the various floors for the west face of WTC 1 during this period were much less than observed on the other faces. Nonetheless, as will be shown, there were indications of considerable fire movement during this time. In Figure 8-49, which was taken from a helicopter at 9:34:48 a.m., only low-level flames were apparent, primarily on the 96th floor. Figure 8-68 shows a similar image taken at 9:41:03 a.m. The areas where fires are observed have increased dramatically.

Fires are now visible near the center of the 94th floor just to the right of the black mark at the top of the columns covers, which starts at column 94-433, and very close to the north edge of the face. Flames are

also present on the 96th floor near the center of the face. This fire has apparently continued its movement to the north, since at 9:34:48 a.m. its northern edge appeared to be near window 96-426, and it can now be seen at least as far as window 96-433. While the flames are not completely visible in the frozen frame shown in Figure 8–68, by reviewing the video it is apparent that this low-intensity fire covers at least thirteen windows.

Figure 8-68. This image of the west face of WTC 1 is a frame captured from a video recorded by a news helicopter at 9:41:03 a.m. The image has been enhanced by adjusting the intensity range, and areas to the left and right of the tower are saturated. Column and floor numbers have been added.

The most dramatic change in the fire distribution is on the 98th floor. At the earlier time there was no indication of fire on the west side of this floor, while in Figure 8–68 flames can be seen over a length running from the south edge of the face to at least window 98-440. From the available imagery, it has proven difficult to determine precisely when this fire appeared, but a review of helicopter video suggests it occurred between 9:38:10 a.m. and 9:39:05 a.m. Given the low intensity of the fire, such apparent rapid fire spread is difficult to understand.

The development of the fire visible in Figure 8–68 on the 94th floor near window 94-430 was sudden. A video shot from a helicopter shows that it appeared at 9:39:08 a.m. The observations of falling people summarized in Appendix M also suggest that fire reached the area shortly after 9:35 a.m. At 9:38:37 a.m. a person was observed falling from this floor near the center of the face. During the next 97 s, at least six more people fell from the same vicinity. Appendix M lists the windows from which some of these people fell. The windows were either 94-435 or 94-437. There was an additional person who came from this

The floor plan layout for the 94th floor in Figure B-3 shows that there were a series of rooms located along the west face. It indicates that window 94-433 was in a room with walls located at columns 94-430 and 94-434, and windows 94-434 to 94-437 were in a second room with walls at columns 94-434 and 94-438. Recall that the glass in windows 94-434 to 94-437 was broken out shortly after 9:00 a.m. and that light smoke was later observed coming from these windows. This smoke flow explains the black band across the tops of the covers for columns 94-433 to 94-437, evident in Figure 8-68.

The other area of fire visible on the 94th floor at the north edge of the west face in Figure 8-68 also appeared abruptly. The video, shot from a helicopter, shows that fire first became visible in window 94-457 at 9:39:54 a.m. This window was located in the northwest corner room, with walls terminating at columns 94-106 and 94-454 (see Figure B-3). Recall that the first visual evidence for fire in this room from the north was at 9:39:51 a.m. The evidence suggests that windows opened on the north and west sides of the room nearly simultaneously, indicating that flashover occurred in the room at this time.

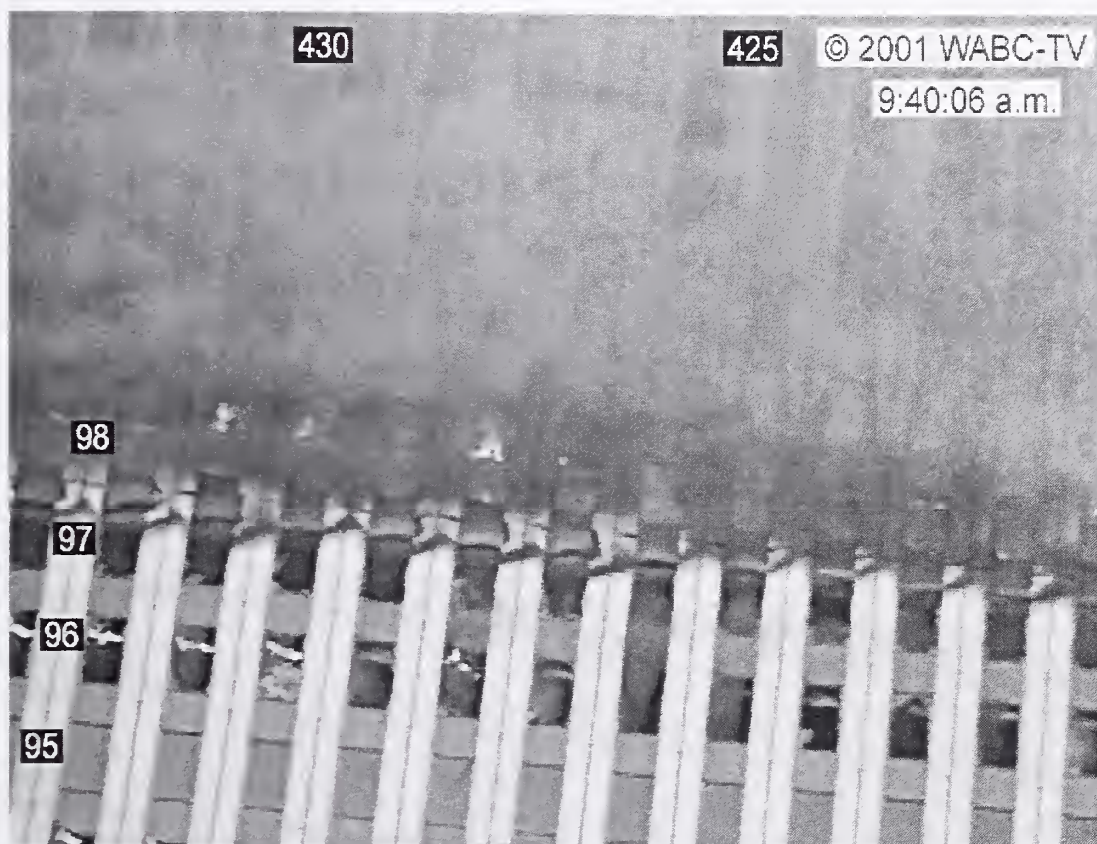
The amount of close-up visual material of the west face is relatively limited, but a close-up video was shot around 9:40 a.m. from just across West Street that provides details concerning the fires and conditions of windows. Figure 8-69 shows a frame captured from this video that was recorded at 9:40:06 a.m. At this time every window visible (windows numbered 420 to 432) on the 96th, 97th, and 98th floors is open, while the glass appears to be intact on the 95th floor and floors above the 98th.

On the 98th floor, a red glow is present in all of the windows, indicating that a fire is burning away from, but near the windows. This is consistent with the appearance of the fires on this floor in Figure 8-68, which was recorded a short time after Figure 8-69. Flames are visible at the tops of several of the windows, particularly windows 98-427, 98-429, and 98-430. It is clear that the flames are positioned just inside of the open windows near the tops of the window frames. The burning material appears to be located on the tops of plates that are hanging down from above. Several of these plates are also visible in windows on the 96th and 98th floors in windows where flames at the tops of windows are not present. It is likely that the plates are actually hanging aluminum head casings (see the discussion in Section 4.2.2) that have dropped down from above the windows as the result of heating. These observations provide additional visual evidence that the burning areas that were frequently observed at the tops of open windows were due to burning polyurethane that was exposed when the aluminum head casings located just inside the tops of the windows at the ceiling dropped down.

There is no indication of active fire on the 97th floor in the video frame. However, the presence of carets at the tops of the aluminum column covers attests to the intensity of the fires that burned on this floor earlier. On some of the columns, portions of the aluminum column covers near the tops of windows appear to have melted.

Figure 8-69. This close up view of the west face of WTC 1 was captured from a video recorded at 9:40:06 a.m. It has been enhanced by adjusting the intensity levels. Column and floors numbers have been added.

Even though fires are clearly present on the 96th floor in the vicinity of the windows at 9:40:06 a.m., they appear to be burning with low intensity. This is consistent with videos shot from helicopters that showed that the fires on this floor were visible intermittently and were located close to the floor. With the exception of the fires at the tops of the windows, flames fill only one opening, window 96-429, and there are no indications of flames coming from the windows. There is very little smoke flowing from this floor, and there are no smoke marks at the tops of the column covers.

In the lower left-hand corner of Figure 8–69, flames can just be seen at the tops of windows 94-430 and 94-431 on the 94th floor. These flames appear to be due to burning thermal insulation, similar to the fires visible on the 96th and 98th floors.

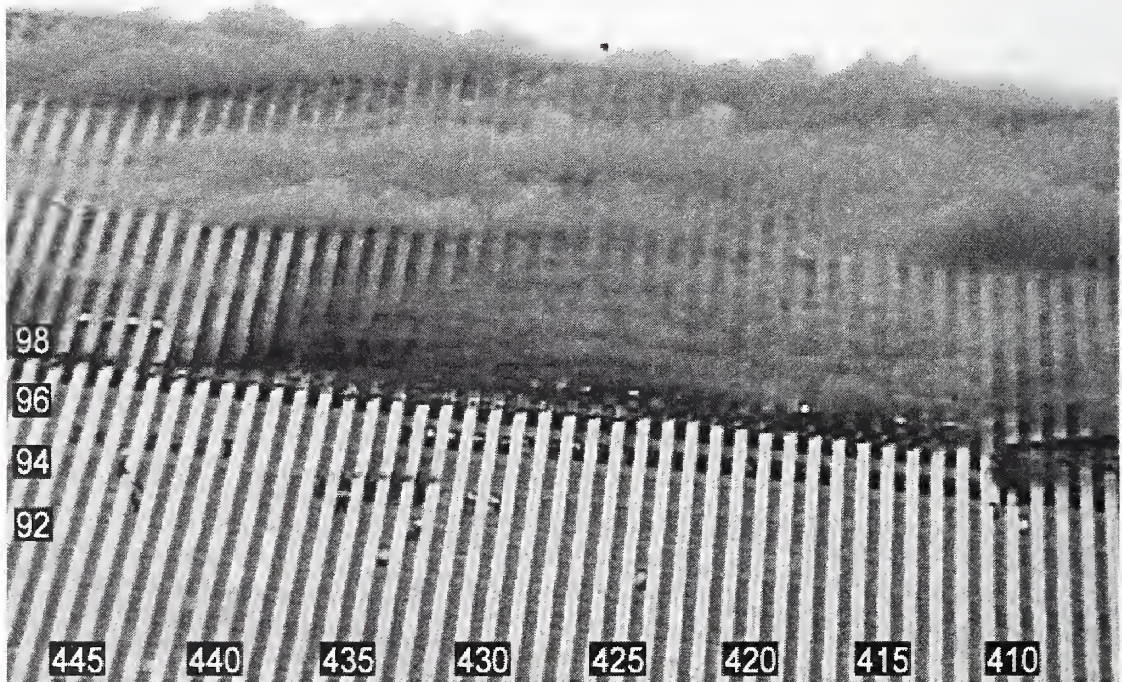
© 2001 WABC-TV
9:40:14 a.m.

Shortly after the video frame in Figure 8–69 was recorded, the camera zoomed out and revealed a larger area of the west face. Figure 8–70 shows a captured frame from this video recorded at 9:40:14 a.m. The image provides sufficient detail to determine whether windows are open or closed. On the 94th floor the only windows in the image that are open are windows 94-430, 94-431, and 94-433 through 94-437. Fires burning at the tops of windows 94-430 and 94-431 can be seen, along with an orange flame in window 94-434. This image was recorded during the period that people were observed falling and climbing down from windows 94-433 to 94-437. The presence of flames in the immediate vicinity suggests that the people had no other means of escape from the spreading fire.

There are no flames evident in the open windows across the entire extent of the 97th floor visible in Figure 8-70. The caret and smoke marks on the column covers near the tops of the windows on this floor contrast sharply with the appearance of the column covers next to the tops of the 96th floor windows.

Figure 8-70. This view of the west face of WTC 1 was captured from a video recorded at 9:40:14 a.m. It has been enhanced by adjusting the intensity levels, and some locations above the building are saturated. Column and floors numbers have been added.

The expanded view of Figure 8-70 shows that fire is visible on the 98th floor from roughly window 98-411 to window 98-439. Further to the north, the window glass appears to be intact. Bright fires are present at the tops of several of the open windows. Larger flames are also present in windows 98-428 and 98-439. Even so, compared to the intense burning observed on the other faces of the tower, these fires appear to be burning relatively gently at this time.

The smoke flows coming from some of the open windows above the 98th floor are quite heavy. At other open windows relatively little smoke is present. The four open windows on the 99th floor, windows 99-445 to 99-448, are an example of the latter behavior.

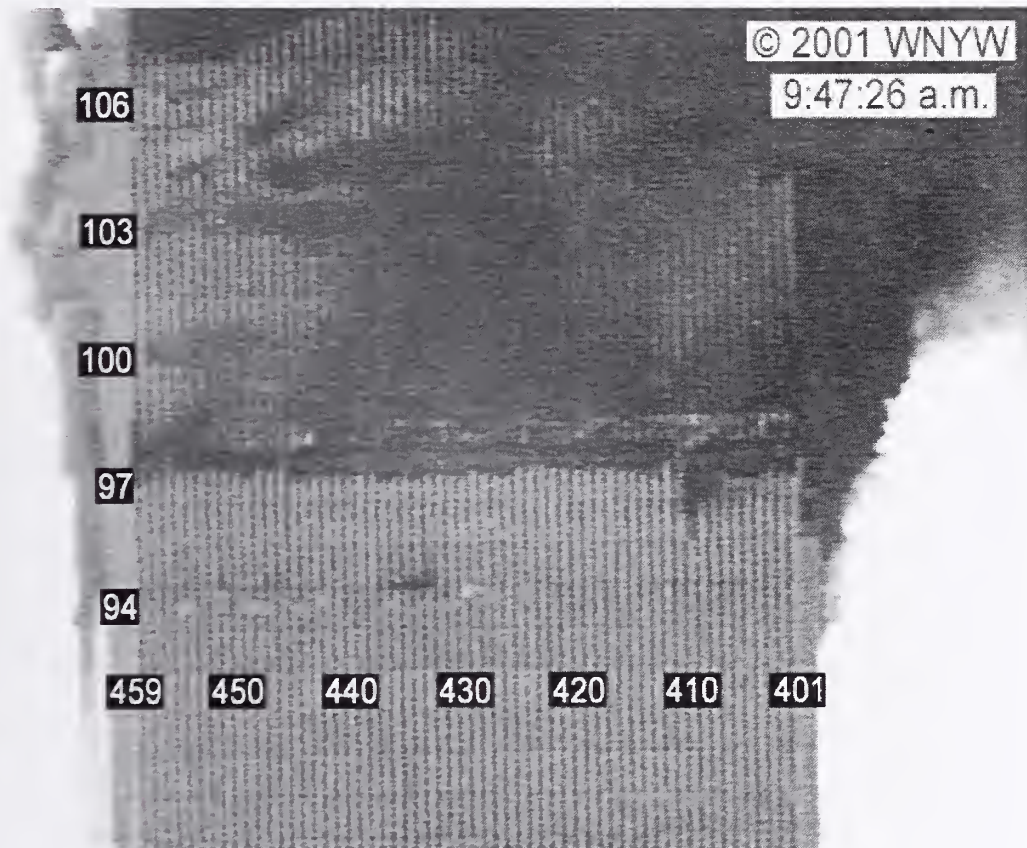
Another view of the west face taken from a video recorded from a news helicopter at 9:47:46 a.m. is shown in Figure 8-71. Since 9:41:03 a.m. (compare with Figure 8-68), the fires on the 94th floor have continued to spread; now appearing at several different locations ranging from the north edge of the face to window 94-425. By comparing the fire locations with the floor plan layout shown in Figure B-3, it is discovered that fires have entered seven of the eight rooms located along the west face, running from the north edge to as far south as column 94-425. The one exception is the room with walls at columns 94-438 and 94-442. Even though the fire area is extensive, the flames are not very vigorous. There is no apparent external flaming, and no smoke is visible coming from the windows.

Figure 8-71. This image of the west face of WTC 1 is a frame captured from a video recorded by a news helicopter at 9:47:26 a.m. The image has been enhanced by adjusting the intensity range, and areas to the left and right of the tower are saturated. Column and floor numbers have been added.

Small fires are still evident on the 96th floor. In the video the flames appear intermittently over a range of windows that reaches as far north as window 96-441. As at the earlier time, there is no smoke or flame coming from the windows.

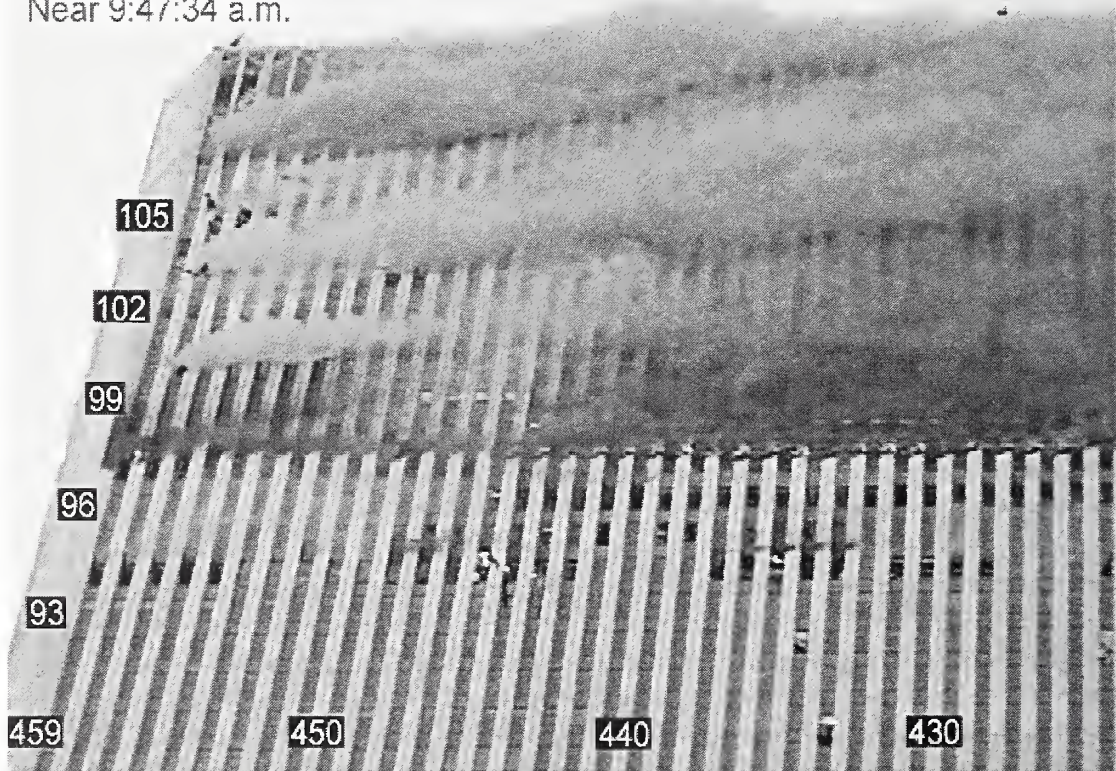
© 2001 WABC-TV
Near 9:47:34 a.m.

A much closer view of the north side of the west face recorded at roughly the same time as Figure 8-71 is shown in Figure 8-72. Even though this image is assigned a time of 9:47:34 a.m., there is an associated uncertainty of 30 s. The closer image provides confirmation of many of the conclusions drawn from Figure 8-71. On the 94th floor fire is visible at many of the windows, and a number are open from window 94-424 to window 94-459. The glass panes between windows 94-438 and 94-442 are indeed in place, with no indication of fire in the room located between these columns (see Figure B-3). The five windows along the west face in the northeast corner room are open. The adjacent room to the south has walls at columns 94-450 and 94-454 (Figure B-3). The fire is apparently just growing in this room since flames are visible, but three of the four windows are in place. Flames are visible, and most of the windows are missing for the next two rooms to the south. Window 94-424 is open, but the panes are still in place in nearby windows. This indicates that the observed fire has moved one room further south since 9:41:03 a.m.

Figure 8-72. This view of the west face of WTC 1 was captured from a video recorded at 9:47:34 a.m. There is a 30 s uncertainty in the assigned time. The image has been enhanced by adjusting the intensity levels, and some locations above the building are saturated. Column and floors numbers have been added.

On the 95th floor, two additional windows (95-438 and 95-439) have opened since 9:40:14 a.m. Since there is still no indication of fire in this area, it is possible that people have broken out the glass. Very

little fire is visible on the 96th floor, but there is an area of flame at the top of window 96-447. Windows to the north of this location are still in place. The northern advance of the fire on the 98th floor has reached roughly the same location. Fire is visible at the top of window 98-444, and window 98-445 appears to be open. A deep red glow on this floor from the windows that are open indicates that burning areas continue to be located well away from the windows.

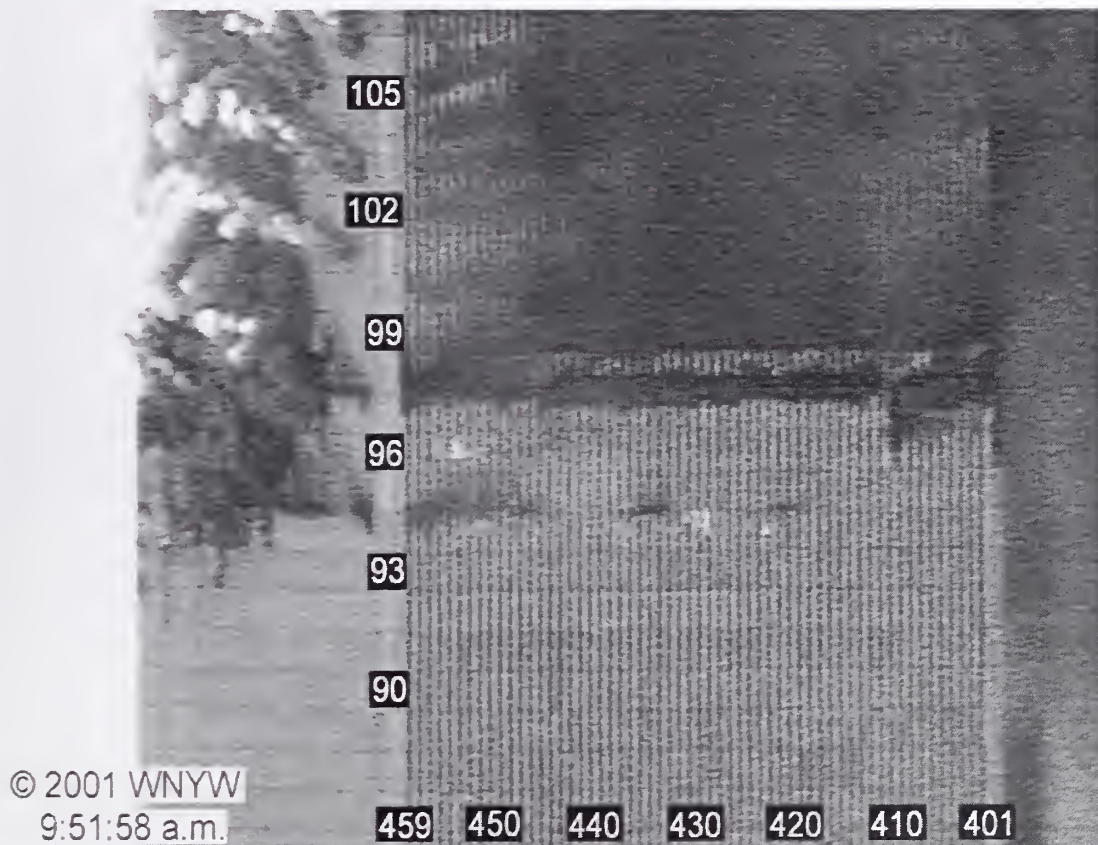
Another frame taken from a video shot from a helicopter at 9:51:58 a.m. is shown in Figure 8-73. Fire development on the west face has continued. The largest differences as compared to Figure 8-71, which was recorded at 9:47:26 a.m., are the appearance of fire at multiple windows on the 96th floor near the north edge of the west face and the spread of the fire toward the south on the 94th floor. It has not been possible to determine exactly when the fire at the north edge of the 96th floor appeared, but it was between 9:50:09 a.m. and 9:51:19 a.m. The flames are visible in windows 96-453 to 96-455. The floor plan layout in Figure B-5 indicates that these windows were inside a room with internal walls at columns 96-452 and 96-456. Fire is not yet visible from windows in the room on the northeast corner with walls at columns 96-456 and 96-108. On the 94th floor flames are now visible in windows 94-423 and 94-424. This indicates that a fire was growing within the room with walls located at columns 94-421 and 94-425. (see Figure B-3) The appearance of the fire on the 98th floor did not change dramatically over the four and a half minute period between the images.

Figure 8-73. This image of the north and west faces of WTC 1 is a frame captured from a video recorded by a news helicopter at 9:51:58 a.m. The image has been enhanced by adjusting the intensity range, and areas to the left of the tower are saturated. Column and floor numbers have been added.

Video footage shows that a dark stream of smoke suddenly appeared near the north edge of the 96th floor at 9:53:08 a.m. Recall that window 96-101 on the north face had opened just 8 s earlier. These observations suggest that the release of smoke was associated with the nearly simultaneous opening of north and west windows in the northwest corner room on this floor. The fact that flames were first visible in the room immediately to the west indicates that the fire most likely moved into the corner room by passing through the wall at column 96-456. In Figure 8-65, which was taken at 9:53:47 a.m., flames are visible at the tops of windows 96-455, 96-456, and 96-457 and lower down in windows 96-452, 96-453, and 96-454. A small fire is evident at window 96-429; otherwise, there is very little evidence of the fires that have spread across the entire west face of this floor after starting at the south edge and moving north.

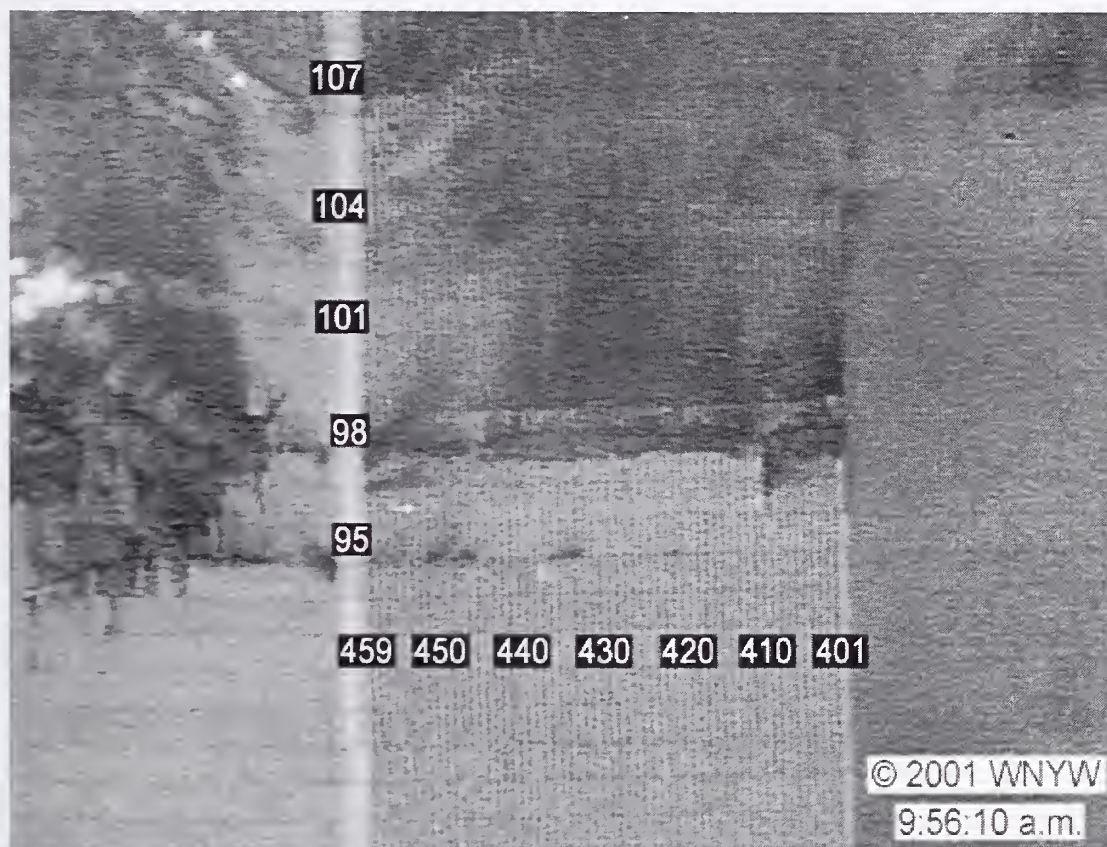
The appearance of the west face at 9:56:10 a.m. is shown in Figure 8-74. The fire distribution has not changed dramatically since 9:51:58 a.m. The amount of smoke coming from the fire floors remains small, and much of the face is visible. For the purposes of later discussion note that while significant smoke is coming from open windows on the south side of the 104th floor, it does not appear to be heavier than from other open windows near the top of the tower. There are no visible indications of a fire on this floor.

Figure 8-74. This image of the north and west faces of WTC 1 is a frame captured from a video recorded by a news helicopter at 9:56:10 a.m. The image has been enhanced by adjusting the intensity range. WTC 2 appears in the background to the right. Column and floor numbers have been added to WTC 1.
